DRG CONSULTING

REMOVAL OF COATINGS

The writer visited South West Pipe Services, Inc. located at 1700 Newman Av. Alvin TX.

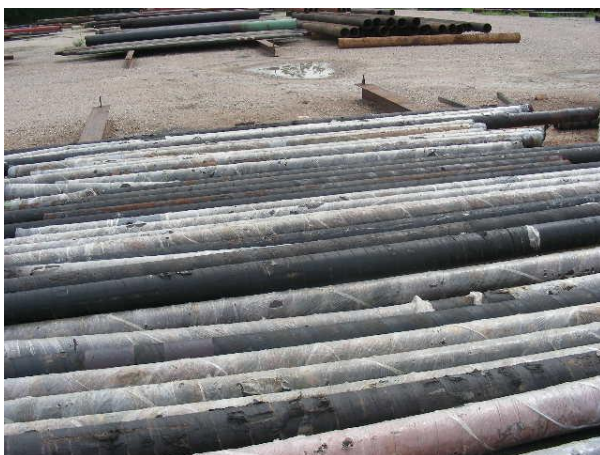
Picture #1

The pipe in question has an existing coating of coal-tar and has been wrapped with felt paper; the goal is to remove the coating to meet a NACE #2, SSPC PA 10 cleanliness standard.

Photograph #1 shows a smaller diameter pipe with the coating still on the pipe, photograph #2 shows the pipe after it was run through the process to remove felt paper and the actual coating and in photograph #3, #4 and #5 is the finished product after the pipe was run through the wire wheel and the substrate was cleaned.

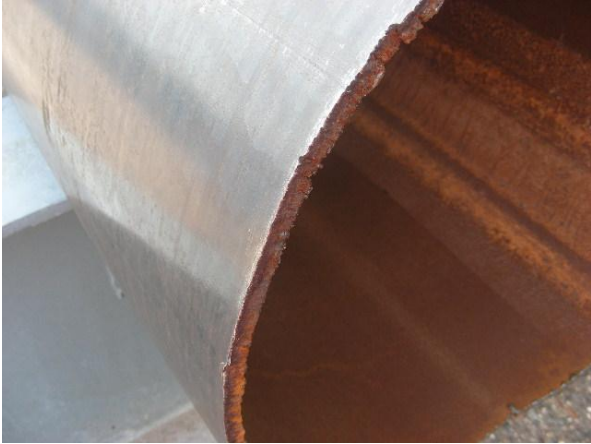
Picture #3

It is my opinion the achievement goal has been met with the understanding that the existing coating was to be removed and the substrate to have the appearance of a NACE #2, SSPC PA 10.
