# Lining Progress Report

Customer: Southwest Pipe Services

Thursday, October 11, 2007

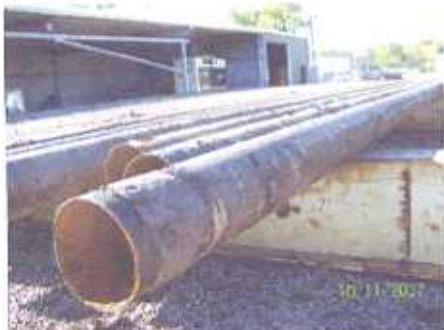
10-11-07 Photograph # 1

The writer visited Southwest Pipe Services' yard in Alvin, Texas. The pipe seen in Photograph # 1 is a "Before" picture while Photograph # 2 is an "After" picture. Southwest is in the process of removing 30 to 50 mils of coal tar and debris from the 12" diameter pipe seen in the photographs.

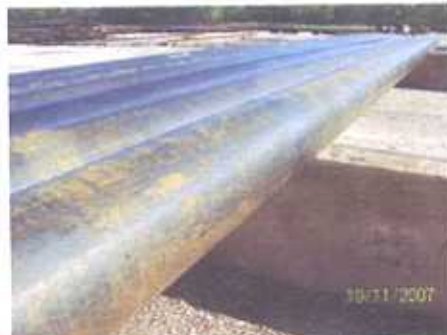
10-11-07 Photograph # 2

Photograph # 3 and # 4 show the pipe as it is coming in contact with the wire brush used to remove the coating. The pipe is actually run through the process three times to remove the material. The goal was to generate a "Commercial" finish. This has been achieved as seen in Photograph # 2 where the pipe was processed yesterday afternoon and has begun rusting overnight after the coating was removed. Over time the entire pipe will achieve a uniform rusty exterior as it comes in contact with the humidity in the air.
